In situ Temperature Evolution and Failure Mechanisms of LiNi_{0.33}Mn_{0.33}Co_{0.33}O₂ Cell under Over-Discharge Conditions

Linmin Wu, Yadong Liu, Yi Cui, Yi Zhang, Jing Zhang*

Department of Mechanical Engineering, Indiana University-Purdue University Indianapolis,
Indianapolis, IN 46202, USA

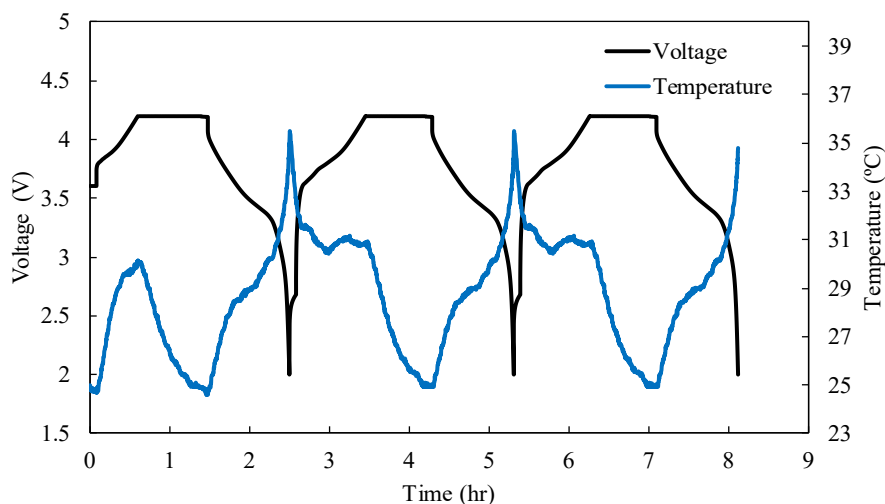
The electrochemical performance of a LG 18650 NMC cell under normal charge-discharge cycles is shown in Fig. 1. The voltage and temperature curves are plotted for the first three cycles. For the constant current charging, the temperature increases 5.2°C for the first cycle and decreases 4°C to 4.5°C for the rest of two cycles. The temperature decreases 5.1°C for the first cycle and 6°C for the rest of two cycles during the constant potential process. There are large increases in temperature of about 10.2°C for the discharge process.

Fig. 1 Voltage and temperature curves of the 18650 NMC cell under normal charge-discharge cycles.

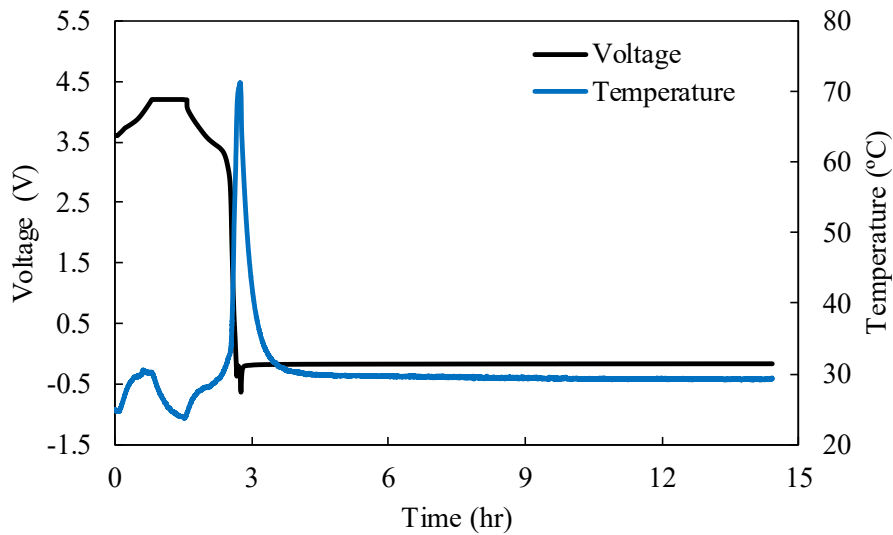
The cell was also cycled in over-discharge conditions. The voltage and temperature curves for the 120% over-discharge are shown in Fig. 2. There is a clear correlation between the voltage and temperature. The cell failed after only 1 cycle. During the over-discharge process, the voltage drops sharply from 2.0 V to -0.8 V, and then goes back to -0.16 V and maintains at -0.16 V. Meanwhile, the skin temperature increases dramatically to 73 °C for over-discharging. After the 120% over-discharge process, the cell was not able to charge, which means the failure of the cell. The large increase of temperature indicating strong exothermal reactions happened inside the cell. This phenomenon implies there might exist micro short circuit inside the cell. It can also be concluded that 120% over-discharge for 18650 NMC cells is extremely detrimental to the cycle performance.

Fig. 2 Voltage and temperature curves of the 18650 NMC cell under 120% over-discharge condition.

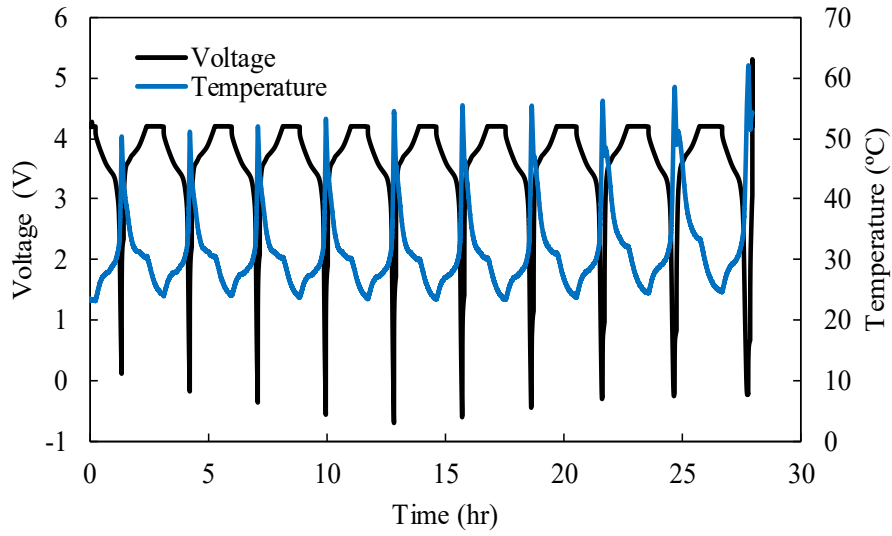
Since the 18650 NMC cell under 120% over-discharge condition failed only after 1 cycle, it is hard to observe the performance change during the cycling. In order to monitor the electrochemical behavior change during the over-discharge process, the NMC cell under 110% over-discharge condition was also studied. The voltage response and monitored temperature for over-discharging is shown in Fig. 3a. Similar to the 120% case, there is a clear correlation between the voltage and temperature. The cell failed after 10 cycles. The voltage at the end of the discharge process becomes negative after 1st cycle. It decreases for the first 5 cycles, and reaches the minimum -0.81 V at the 5th cycle. And then, the voltage increases until the 10th cycle. At the end of the 10th cycle, the voltage is still negative, which is -0.21 V. After 10th cycle, the voltage increases dramatically to 5.62 V and the cell was unable to discharge, which implying the failure. The temperature evolution during the over-discharge condition is also shown in Fig. 3a. The temperature increases from 23.2 °C to 61.7 °C. The temperature at the end of discharge process, which is the peak temperature at each cycle, shows a trend of increase with a rate of 1.13 °C/cycle (see Fig. 3b), while the temperature at the end of the charging process has a much smaller increase speed, which is 0.16 °C/cycle. The peak temperature values and discharge capacity retention of the NMC cell are given in Fig. 3b. With the increase of the cycle number, the capacity retention decreases from 100% to 99.7% for the first 7 cycles, and then decreases sharply to 96.7% at the end of 10th cycle. Meanwhile, the peak temperature of the NMC cell increases sharply from 55.1 °C to 61.74 °C for 7th cycle to 10th cycle. The above observations suggest the micro short circuits formed under 110% over-discharge conditions, and strong exothermal reactions occurred inside the cell. With the increase of the cycling number, the micro short circuits were developing, which can cause further damage to the electrochemical performance.

Fig. 3 (a) Voltage and temperature curves of the 18650 NMC cell under 110% over-discharge condition. (b) Peak temperature and discharge capacity retention of the 18650 NMC cell under 110% over-discharge condition.

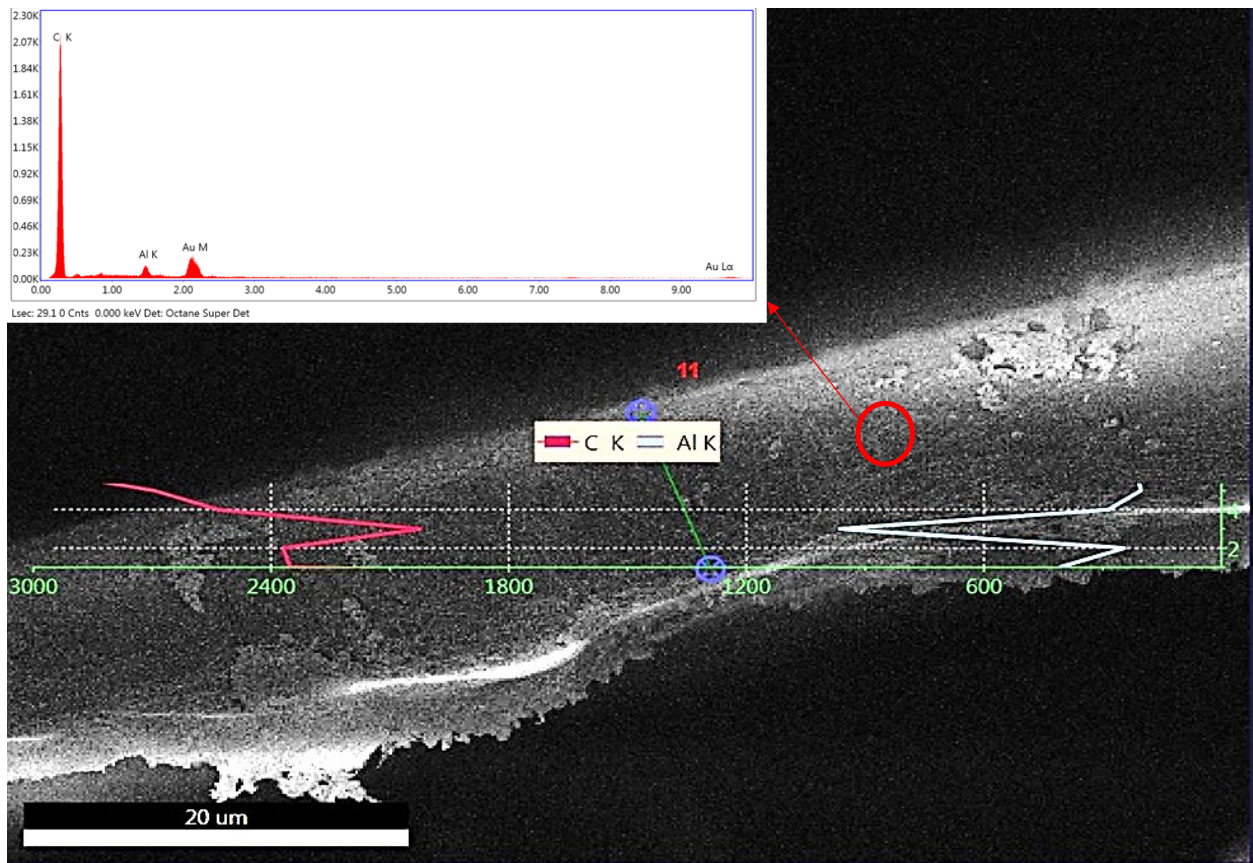
Fig. 4 SEM image of the separator under normal charge-discharge condition. EDX line and area scan results are shown in the image.

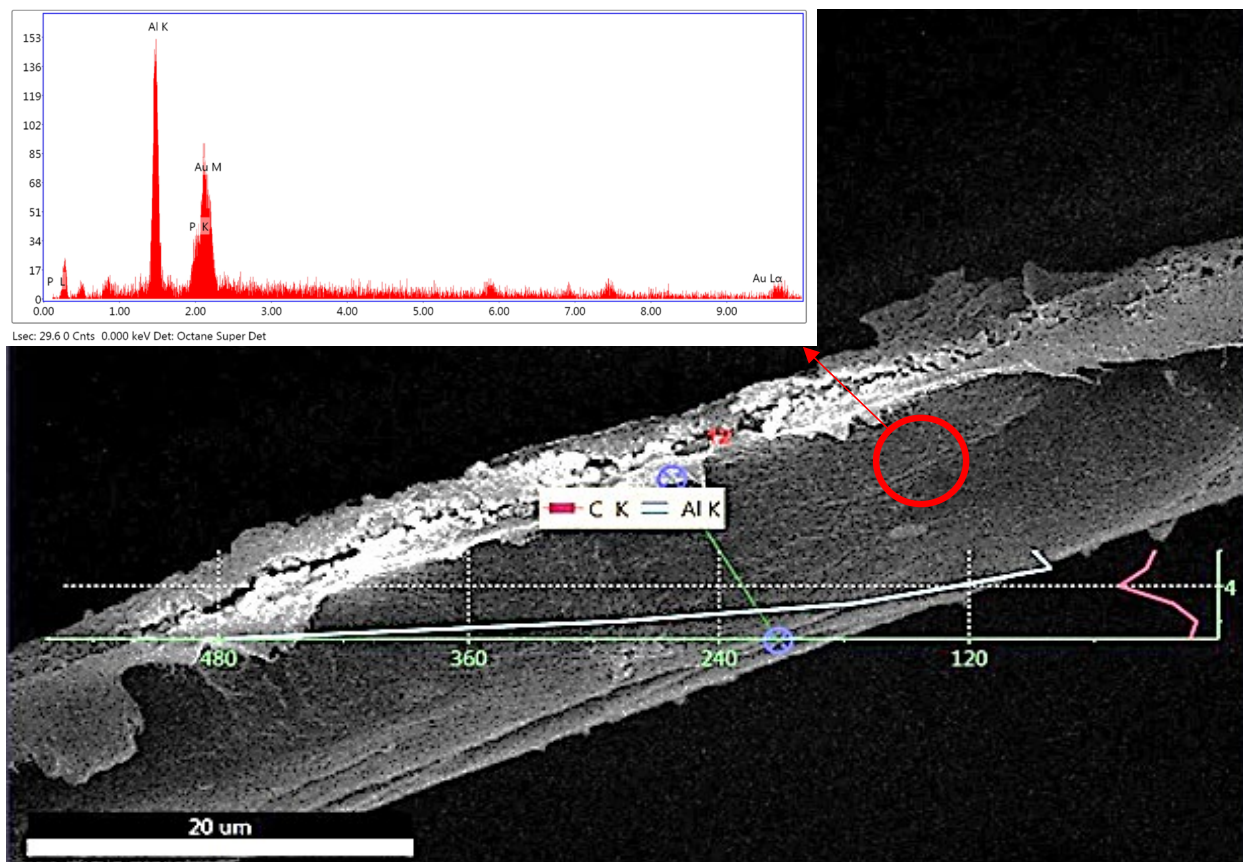
the increase of the cycle number, leading to a uniform distribution of the melted spots. Similar to the 110% over-discharged sample, large amounts of aluminum were found inside the 120% over-discharged separator (see Fig. 6), and the content of aluminum is higher than carbon. Although EDX results can not show absolute contents of the elements, it can show the changes of relative contents. The relative amount of aluminum increases dramatically after over-discharging. It seems like something formed in the separator during over-discharging.

Fig. 6 SEM image of the separator under 120% over-discharge condition. EDX line and area scan results are shown in the image.

short circuit during over-discharging, other ceramic material needs to be used as additives to the separator instead of aluminum. Such ceramic additives should have high temperature tolerance and good chemical stability inside the battery.

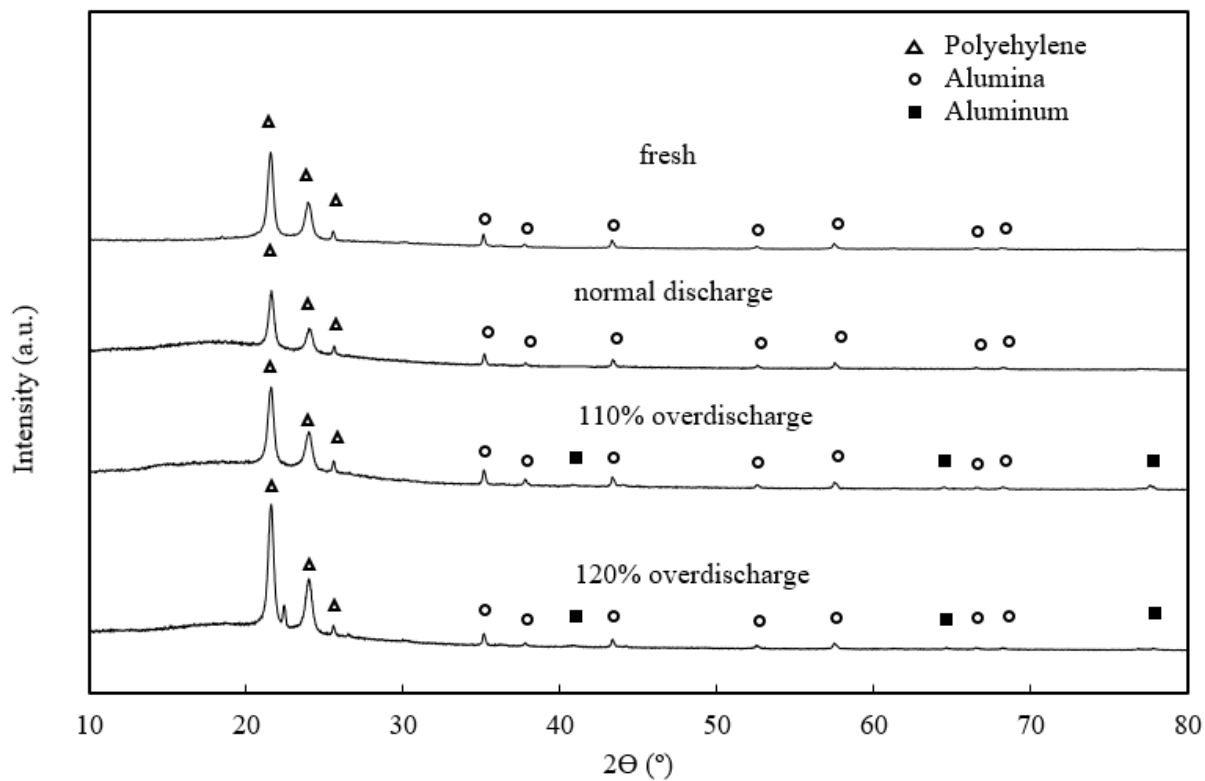
X-ray diffraction was conducted to reveal the compositional change inside the separator after over-discharging. The XRD patterns for the fresh separator, and the separators under normal discharge, 110% over-discharge and 120% over-discharge conditions are shown in Fig. 7 (a) and (b). Before 30° , the peaks of polyethylene, which is the major composition of the separator, were shown. Meanwhile, some alumina peaks were found in both cycled and uncycled separators. This implies that the alumina was not formed inside the separator during the charge and discharge process, and it was coated inside the separator during the manufacturing process. It is noted that

around 41° , 65° and 78° , the aluminum peaks exist for the separators under 110% and 120% over-discharge conditions, while no aluminum was found for the fresh separator and the separator under normal discharge condition. This suggests the aluminum was formed inside the separator under over-discharge conditions.

Fig. 7 XRD patterns for fresh separator, and separators under normal, 110% and 120% over-discharge conditions. (a) 2θ ranges from 10° to 80° ; (b) 2θ ranges from 30° to 80° . The XRD patterns were zoomed in to make alumina and aluminum peaks more visible.

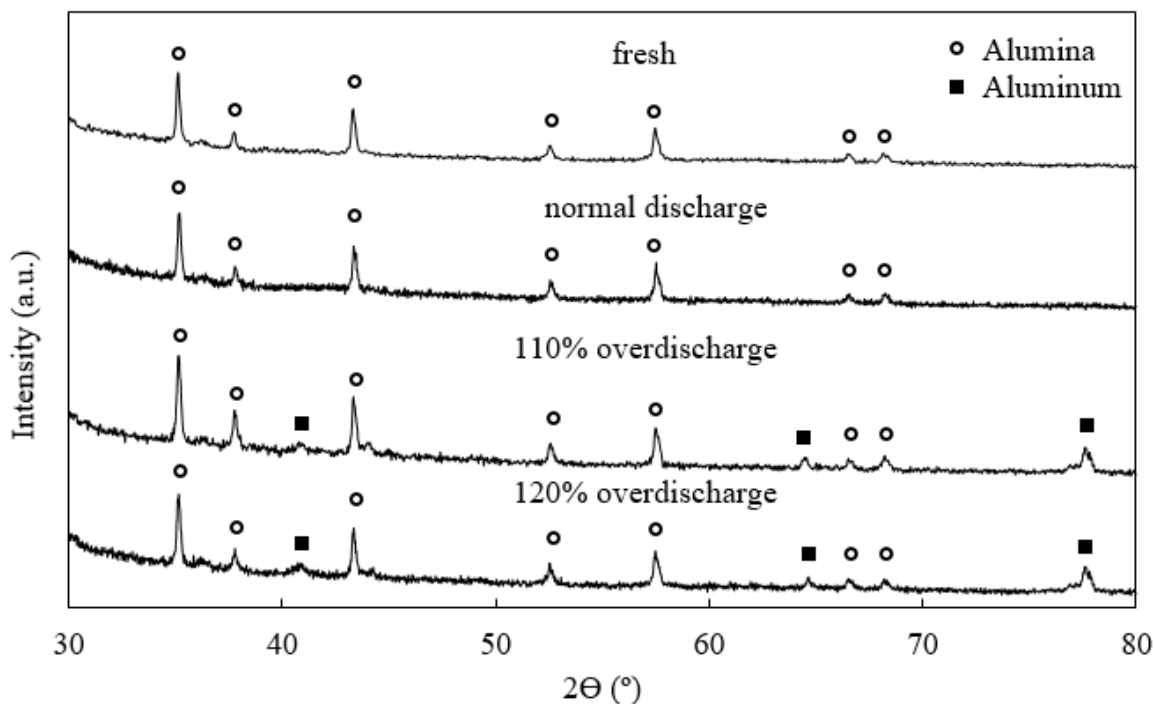
(b)

Combined XRD patterns with the SEM images and EDX results, it can be concluded that pure aluminum was formed in the separator during the over-discharge process, which has not been observed in the literatures. It seems that under high temperature, the alumina in the separator was reduced and formed pure aluminum. However, this reduction reaction is still unknown and needs further investigation. Once the pure aluminum accumulates and connects with each other, an electron-conducting channel will be formed inside the separator. The occurrence of aluminum will cause micro short circuit, which leads to the failure of the cells. In order to prevent the internal
